**Flood Control Project Maintenance
Levee Inspections**
LMA District Cover Sheet
Spring 2018 Levee Inspection Results

Sacramento Maintenance Yard Maintenance Area 0009

Spring 2018 Levee Inspection Results

Waterway	Bank	Unit Miles
Unit No. 01 Sacramento River	Left	19.35

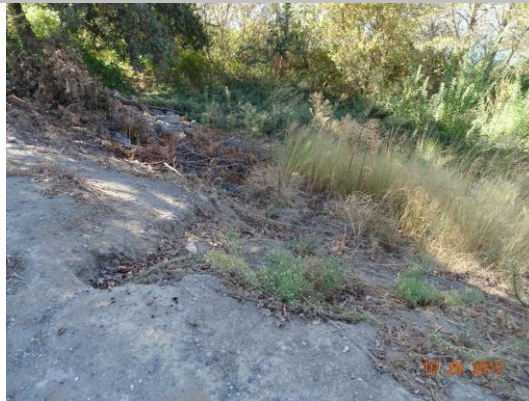
Photo 1 of 1 : SP_2018_MA0009_201_234_20180306_00178.jpg

LM Start	4.70	Rating **	A/W	Issue No.	234
LM End	4.70	Issue Type +	Ma	Location *	WS
Category	Supplemental			GPS Latitude/Longitude	
				Start	End
Item	2017 Storm Damage			38.499824 °	38.499824 °
				-121.557934 °	-121.557934 °
DWR ID	DWR_MA0009_01_f_2017_234				
Comment Code					
Inspector Comment					
Levee Evaluation Comments					
Description:					
Site ID No:55					
Site Designation:MA9-02					
Repair Type: Erosion					
Rating:Area of Concern					
Field Date:5/18/2017					
Notes: This site was visited but no data was recorded at the time. The Sac Yard is planning on repairing this site. Damage looks like it may have been caused by a nearby resident draining a pool with a hose.

View of erosion on waterside slope. Fall 2017.

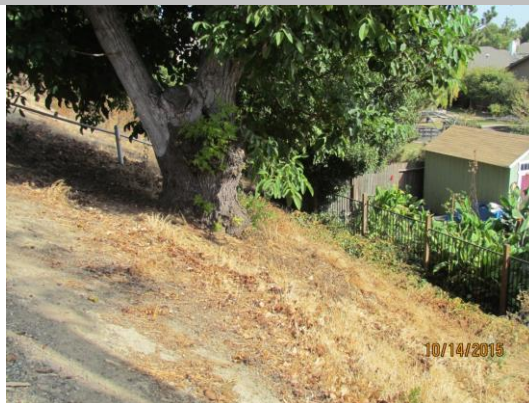
Photo 1 of 1 : SP_2018_MA0009_201_131_20180306_00081.jpg

LM Start	4.71	Rating **	M	Issue No.	131
LM End	4.71	Issue Type +	En	Location *	LS
Category	Earthen Levee			GPS Latitude/Longitude	
				Start	End
Item	Vegetation			38.499636 °	38.499636 °
				-121.557871 °	-121.557871 °
DWR ID	DWR_MA0009_01_s_2012_131				
Comment Code					
V6 : Landscaping					
Inspector Comment

View of the landscaping on the landward side of the levee looking upstream. Blackberry shrubs are at the toe of the levee. Fall 2015.

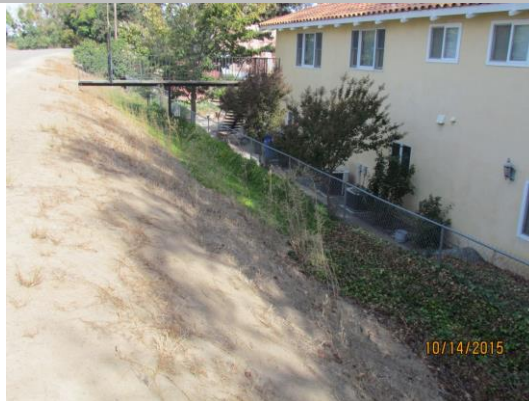
Photo 2 of 2 : SP_2018_MA0009_201_135_20180306_00087.jpg

LM Start	4.96	Rating **	M	Issue No.	135 (cont)	
LM End	4.98	Issue Type +	En	Location *	LS	
Category	Earthen Levee			GPS Latitude/Longitude		
				Start		End
Item	Encroachments			38.496110 °		38.495871 °
				-121.556939 °		-121.556777 °
DWR ID	DWR_MA0009_01_s_2012_135					
Comment Code						
RW : Retaining Wall						
Inspector Comment

View of the landscaping on the landward side of the levee looking upstream. The retaining wall has been covered by the groundcover. Fall 2015.

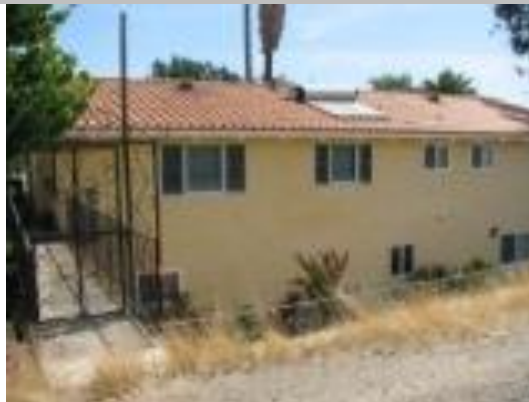
Photo 1 of 1 : SP_2018_MA0009_201_136_20180306_00088.jpg

LM Start	4.97	Rating **	M	Issue No.	136
LM End	4.97	Issue Type +	En	Location *	LS
Category	Earthen Levee			GPS Latitude/Longitude	
				Start	End
Item	Encroachments			38.495981 °	38.495981 °
				-121.556864 °	-121.556864 °
DWR ID	DWR_MA0009_01_s_2012_136				
Comment Code					
BU : Building					
Inspector Comment

The two story house was built at the toe of the levee.

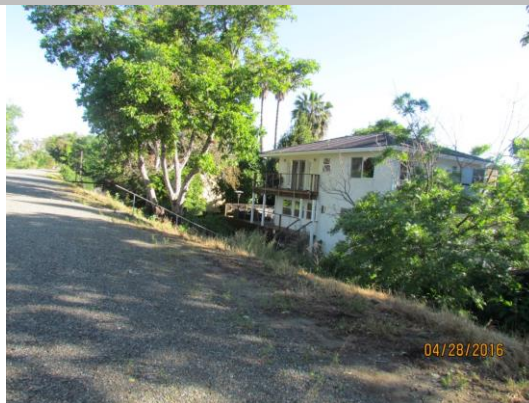
Photo 1 of 1 : SP_2018_MA0009_201_138_20180306_00089.jpg

LM Start	4.99	Rating **	M	Issue No.	138
LM End	4.99	Issue Type +	En	Location *	LS
Category	Earthen Levee			GPS Latitude/Longitude	
				Start	End
Item	Encroachments			38.495687 °	38.495687 °
				-121.556705 °	-121.556705 °
DWR ID	DWR_MA0009_01_s_2012_138				
Comment Code					
BU : Building					
Inspector Comment

View of the house at the toe of the levee on the landward side looking upstream. Spring 2016.

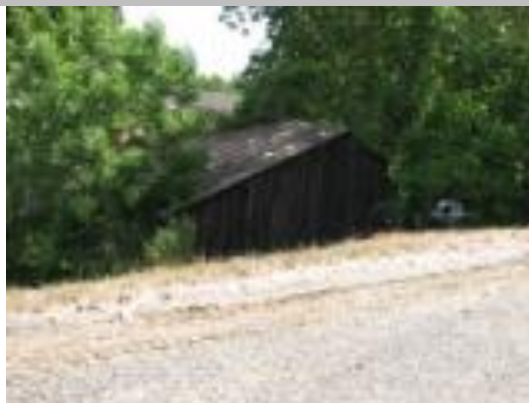
Photo 1 of 2 : SP_2018_MA0009_201_139_20180306_00090.jpg

LM Start	5.01	Rating **	M	Issue No.	139
LM End	5.01	Issue Type +	En	Location *	LS
Category	Earthen Levee			GPS Latitude/Longitude	
				Start	End
Item	Encroachments			38.495529 °	38.495529 °
				-121.556592 °	-121.556592 °
DWR ID	DWR_MA0009_01_s_2012_139				
Comment Code					
BU : Building					
Inspector Comment

The side of the barn is into levee toe.

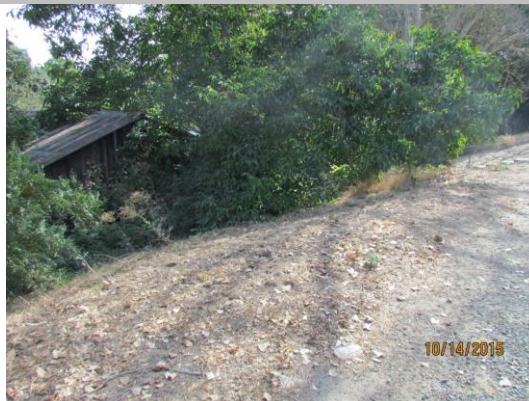
Photo 2 of 2 : SP_2018_MA0009_201_139_20180306_00091.jpg

View of the barn at the levee toe on the landward side of the levee. Trees need to be trimmed for visibility. Fall 2015.

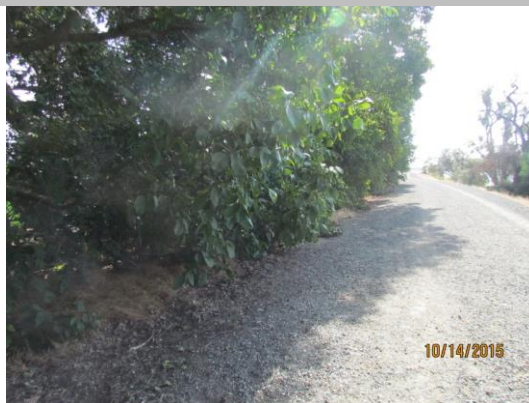
Photo 2 of 2 : SP_2018_MA0009_201_328_20180306_00262.jpg

View of the trees on the landward side of the levee looking downstream. Trees need to be trimmed. Fall 2015.

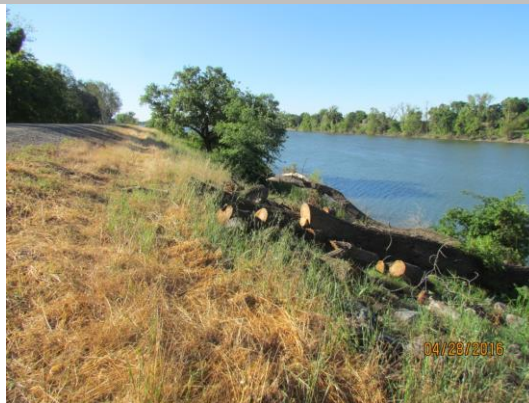
Photo 1 of 1 : SP_2018_MA0009_201_336_20180306_00273.jpg

LM Start	5.08	Rating **	M	Issue No.	336
LM End	5.08	Issue Type +	Ma	Location *	WS
Category	Earthen Levee			GPS Latitude/Longitude	
				Start	End
Item	Encroachments			38.494527 °	38.494527 °
				-121.555889 °	-121.555889 °
DWR ID	DWR_MA0009_01_s_2016_336				
Comment Code					
TR : Tree or limb					
Inspector Comment

View of the fallen tree on the waterward slope looking downstream. Spring 2016.

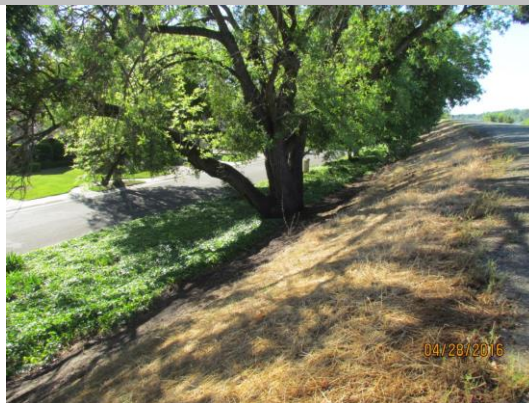
Photo 1 of 1 : SP_2018_MA0009_201_141_20180306_00092.jpg

LM Start	5.09	Rating **	M	Issue No.	141
LM End	5.17	Issue Type +	En	Location *	LS
Category	Earthen Levee			GPS Latitude/Longitude	
				Start	End
Item	Vegetation			38.494477 °	38.493431 °
				-121.555809 °	-121.555082 °
DWR ID	DWR_MA0009_01_s_2012_141				
Comment Code					
V6 : Landscaping					
Inspector Comment

View of the groundcover planted on the berm on the landward side of the levee looking downstream. Spring 2016.

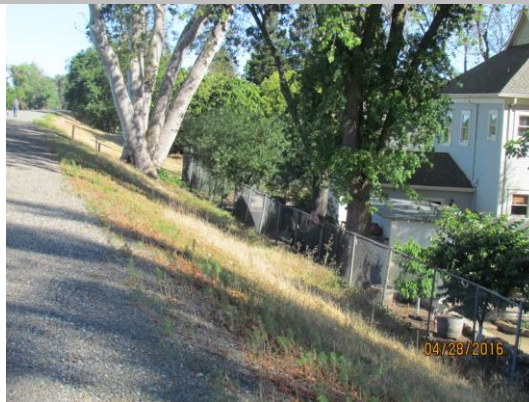
Photo 1 of 1 : SP_2018_MA0009_201_143_20180306_00093.jpg

LM Start	5.24	Rating **	M	Issue No.	143
LM End	5.28	Issue Type +	En	Location *	LS
Category	Earthen Levee			GPS Latitude/Longitude	
				Start	End
Item	Vegetation			38.492574 °	38.492131 °
				-121.554423 °	-121.554072 °
DWR ID	DWR_MA0009_01_f_2017_143				
Comment Code					
V6 : Landscaping					
Inspector Comment

View of the landscaping at the toe of the levee on the landward side looking upstream. Spring 2016.

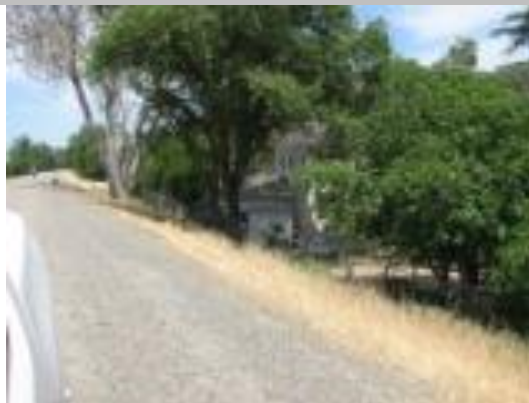
Photo 1 of 2 : SP_2018_MA0009_201_145_20180306_00095.jpg

LM Start	5.25	Rating **	M	Issue No.	145
LM End	5.25	Issue Type +	En	Location *	LS
Category	Earthen Levee			GPS Latitude/Longitude	
				Start	End
Item	Encroachments			38.492442 °	38.492442 °
				-121.554319 °	-121.554319 °
DWR ID	DWR_MA0009_01_s_2012_145				
Comment Code					
BU : Building					
Inspector Comment

The building encroaches into the levee.

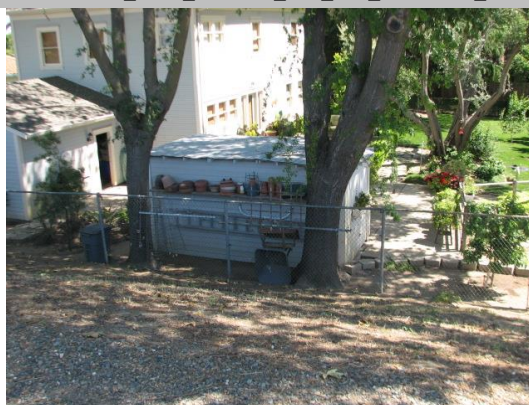
Photo 2 of 2 : SP_2018_MA0009_201_145_20180306_00096.jpg

A garden shed at the toe of the levee. Spring 2014

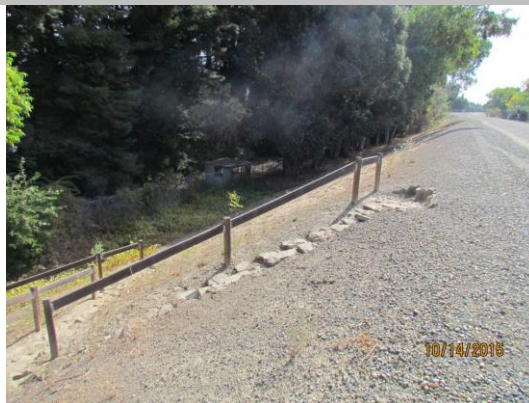
Photo 1 of 1 : SP_2018_MA0009_201_146_20180306_00097.jpg

LM Start	5.28	Rating **	M	Issue No.	146
LM End	5.32	Issue Type +	En	Location *	LS
Category	Earthen Levee			GPS Latitude/Longitude	
				Start	End
Item	Vegetation			38.492132 °	38.491623 °
				-121.554072 °	-121.553634 °
DWR ID	DWR_MA0009_01_s_2018_146				
Comment Code					
V6 : Landscaping					
Inspector Comment

View of the landscaping along the toe of the levee on the landward side looking downstream. Fall 2015.

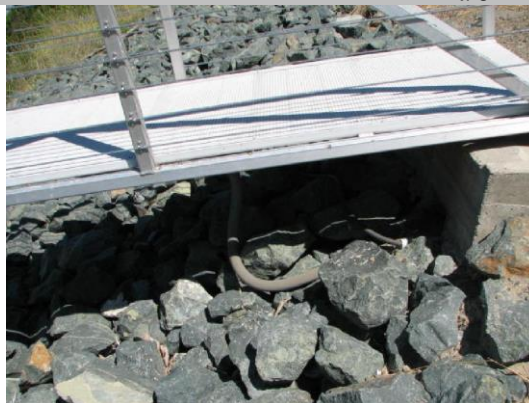
Photo 1 of 2 : UCIP_SP_2018_5900_8962.jpg

LM Start	5.31	Rating **	M	Issue No.	1791
LM End	5.31	Issue Type +	En	Location *	
Category	Supplemental			GPS Latitude/Longitude	
				Start	End
Item	DWR UCIP Field Study			38.491750 °	38.491750 °
				-121.553730 °	-121.553730 °
DWR ID					
Comment Code					
Inspector Comment					
FS_ID:5900 DS_ID:18943 EP_NO: 12922 Repair Type: Non-Urgent Crossing Status: Found UCIP Comments: No permit identified for this crossing. FIELD_STRUCT_DESC: 1 of 2: 2-inch electrical conduit of an unknown material through the levee, at an unknown depth. Conduit located on the downstream side of the boat dock ramp. FS Date: 6/20/2012 2:20:30 PM

Pipes under walkway on WS at ramp.

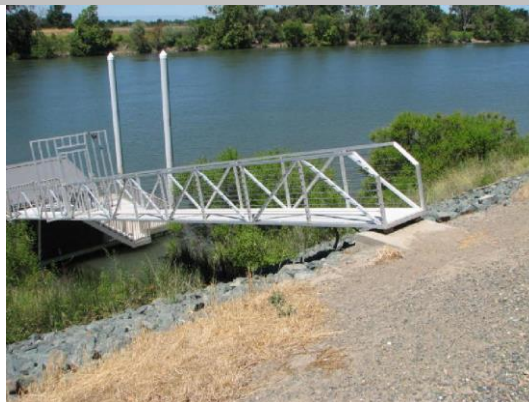
Photo 2 of 2 : UCIP_SP_2018_5900_8961.jpg

Ramp at WS shoulder.

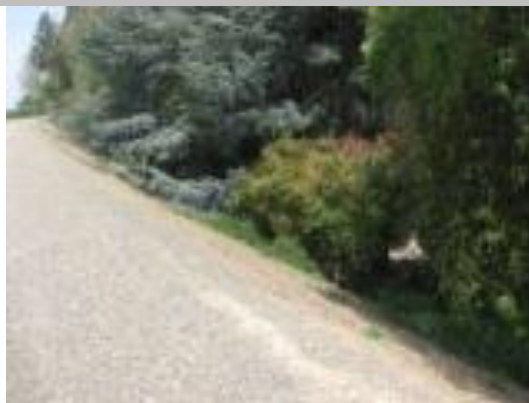
Photo 1 of 2 : SP_2018_MA0009_201_148_20180306_00098.jpg

LM Start	5.34	Rating **	U	Issue No.	148
LM End	5.38	Issue Type +	En	Location *	LS
Category	Earthen Levee			GPS Latitude/Longitude	
				Start	End
Item	Vegetation			38.491357 °	38.490897 °
				-121.553393 °	-121.552974 °
DWR ID	DWR_MA0009_01_s _ 2012_148				
Comment Code					
V6 : Landscaping					
Inspector Comment					
Landscaping blocks visibility of levee slopes.

The cedar tree covers the levee slope blocks visibility. Photo taken spring 2012.

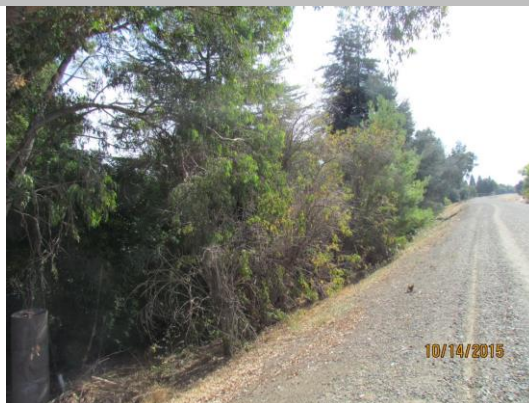
Photo 2 of 2 : SP_2018_MA0009_201_148_20180306_00099.jpg

View of the landscaping along the levee slope on the landward side looking downstream. Fall 2015.

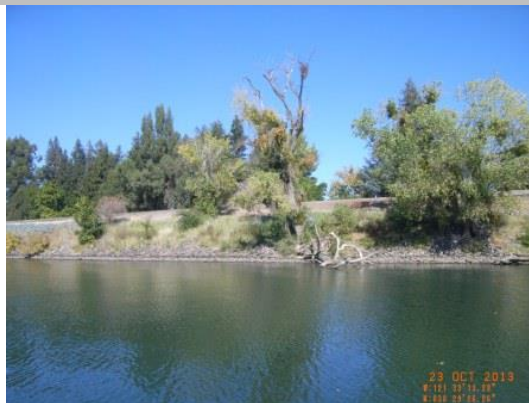
Photo 1 of 1 : SP_2018_MA0009_201_16_20180306_00014.jpg

LM Start	5.35	Rating **	M	Issue No.	16
LM End	5.37	Issue Type +	Ma	Location *	WS
Category	Supplemental			GPS Latitude/Longitude	
				Start	End
Item	2015 USACE Erosion Survey, DRAFT			38.491086 °	38.490892 °
				-121.553540 °	-121.553352 °
DWR ID	DWR_MA0009_01_s_2016_16				
Comment Code					
Inspector Comment					
2011 - Tree popout at the toe has taken out the rock toe protection. 2015: No observed changes. [2015 Site ID: SAC_50-3_L]

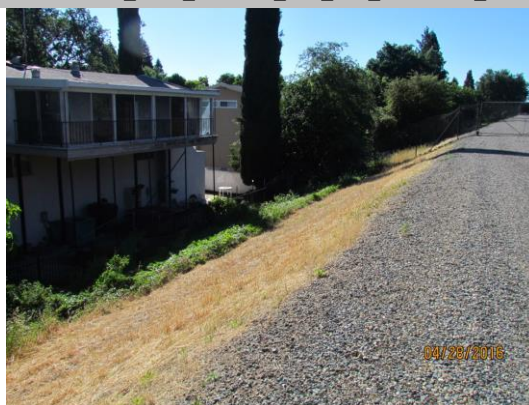
Photo 1 of 1 : SP_2018_MA0009_201_149_20180306_00100.jpg

LM Start	5.44	Rating **	M	Issue No.	149
LM End	5.46	Issue Type +	En	Location *	LS
Category	Earthen Levee			GPS Latitude/Longitude	
				Start	End
Item	Vegetation			38.490197 °	38.490023 °
				-121.552327 °	-121.552153 °
DWR ID	DWR_MA0009_01_s_2012_149				
Comment Code					
V6 : Landscaping					
Inspector Comment

View of the landscaping at the toe of the levee on the landward side looking downstream. Spring 2016.

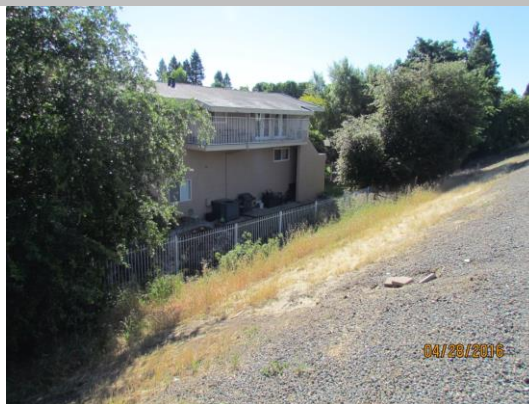
Photo 1 of 1 : SP_2018_MA0009_201_150_20180306_00101.jpg

LM Start	5.46	Rating **	M	Issue No.	150
LM End	5.47	Issue Type +	En	Location *	LS
Category	Earthen Levee			GPS Latitude/Longitude	
				Start	End
Item	Encroachments			38.489974 °	38.489807 °
				-121.552121 °	-121.551990 °
DWR ID	DWR_MA0009_01_s_2012_150				
Comment Code					
FE : Fence					
Inspector Comment

View of the fence and landscaping at the toe of the levee looking downstream. Spring 2016.

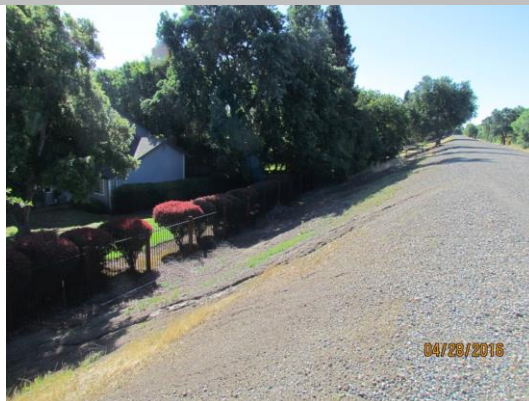
Photo 1 of 1 : SP_2018_MA0009_201_151_20180306_00102.jpg

LM Start	5.48	Rating **	M	Issue No.	151
LM End	5.50	Issue Type +	En	Location *	LS
Category	Earthen Levee			GPS Latitude/Longitude	
				Start	End
Item	Vegetation			38.489730 °	38.489503 °
				-121.551924 °	-121.551748 °
DWR ID	DWR_MA0009_01_s _ 2012_151				
Comment Code					
V6 : Landscaping					
Inspector Comment

View of the pruned shrubs at the toe of the levee on the landward side looking downstream. Spring 2016.

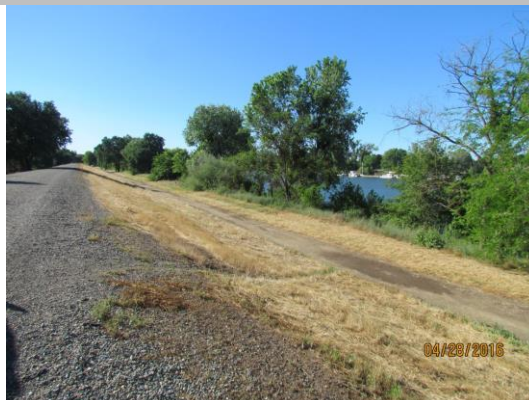
Photo 1 of 2 : SP_2018_MA0009_201_132_20180306_00082.jpg

LM Start	5.49	Rating **	A/W	Issue No.	132
LM End	5.93	Issue Type +	En	Location *	WS
Category	Earthen Levee			GPS Latitude/Longitude	
				Start	End
Item	Vegetation			38.489589 °	38.484026 °
				-121.551825 °	-121.547831 °
DWR ID	DWR_MA0009_01_s _ 2012_132				
Comment Code					
V8 : Environmental Requirements.					
Inspector Comment

View of the revegetation site on the waterward berm of the levee looking downstream. Spring 2016.

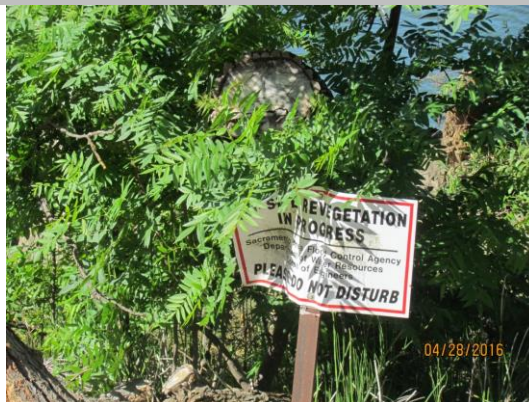
Photo 2 of 2 : SP_2018_MA0009_201_132_20180306_00083.jpg

Sign stating the revegetation site. Spring 2016.

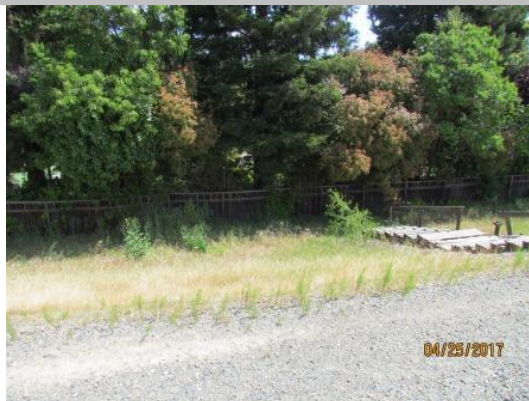
Photo 1 of 2 : SP_2018_MA0009_201_152_20180306_00103.jpg

LM Start	5.50	Rating **	U	Issue No.	152
LM End	5.53	Issue Type +	En	Location *	LS
Category	Earthen Levee			GPS Latitude/Longitude	
				Start	End
Item	Encroachments			38.489476 °	38.489125 °
				-121.551736 °	-121.551466 °
DWR ID	DWR_MA0009_01_f_2017_152				
Comment Code					
FE : Fence					
Inspector Comment

View of fence at landside levee toe. Spring 2017.

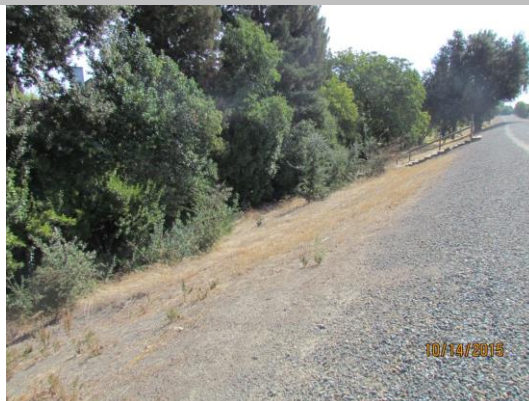
Photo 2 of 2 : SP_2018_MA0009_201_152_20180306_00104.jpg

LM Start	5.50	Rating **	U	Issue No.	152 (cont)
LM End	5.53	Issue Type +	En	Location *	LS

View of the landscaping at the toe of the levee on the landward side looking downstream. Fall 2015.

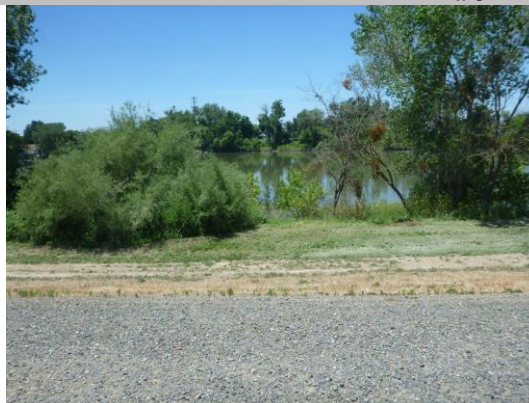
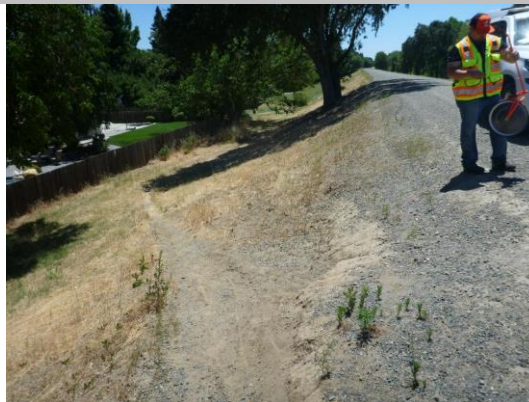
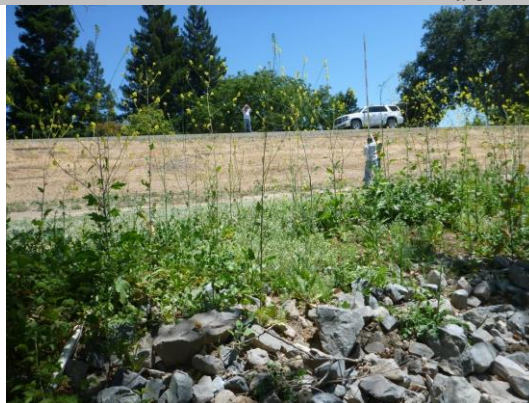
LM Start	5.52	Rating **	A/W	Issue No.	238
LM End	5.52	Issue Type +	Ma	Location *	
Category	Supplemental			GPS Latitude/Longitude	
				Start	End
Item	2017 Storm Damage			38.489231 °	38.489179 °
				-121.551502 °	-121.551473 °
DWR ID	DWR_MA0009_01_f_2017_238				
Comment Code					
Inspector Comment					
Levee Evaluation Comments					
Description:					
Site ID No:233					
Site Designation:LMA-66					
Repair Type: Erosion					
Rating:Area of Concern					
Field Date:2/10/2017					
Notes: existing riparian scrub

LM Start	5.52	Rating **	A/W	Issue No.	238 (cont)	
LM End	5.52	Issue Type +	Ma	Location *		
Category	Supplemental			GPS Latitude/Longitude		
				Start	End	
Item	2017 Storm Damage			38.489231 °	38.489179 °	
				-121.551502 °	-121.551473 °	
DWR ID	DWR_MA0009_01_f_2017_238					
Comment Code						
Inspector Comment						
Levee Evaluation Comments						
Description:						
Site ID No:233						
Site Designation:LMA-66						
Repair Type: Erosion						
Rating:Area of Concern						
Field Date:2/10/2017						
Notes: existing riparian scrub

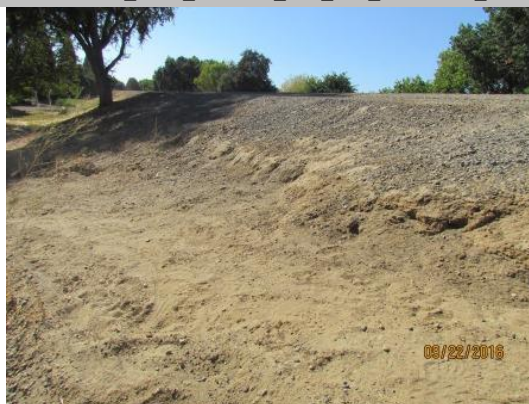
Photo 1 of 2 : SP_2018_MA0009_201_358_20180306_00287.jpg

View of the site on LS of the levee looking downstream. Fall 2016.

LM Start	5.52	Rating **	M	Issue No.	358
LM End	5.52	Issue Type +	Ma	Location *	LS
Category	Earthen Levee			GPS Latitude/Longitude	
				Start	End
Item	Slope Stability			38.489181 °	38.489181 °
				-121.551510 °	-121.551510 °
DWR ID	DWR_MA0009_01_s_2016_358				
Comment Code					
S3 : Repair the levee slope damaged by vehicle traffic and prevent access where possible.					
Inspector Comment

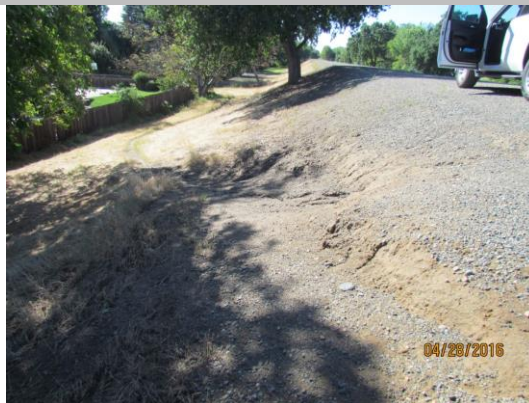
Photo 2 of 2 : SP_2018_MA0009_201_358_20180306_00288.jpg

View of the slope stability on the landward side of the levee looking downstream. Spring 2016.

LM Start	5.52	Rating **	M	Issue No.	358 (cont)	
LM End	5.52	Issue Type +	Ma	Location *	LS	
Category	Earthen Levee			GPS Latitude/Longitude		
				Start		End
Item	Slope Stability			38.489181 °		38.489181 °
				-121.551510 °		-121.551510 °
DWR ID	DWR_MA0009_01_s_2016_358					
Comment Code						
S3 : Repair the levee slope damaged by vehicle traffic and prevent access where possible.						
Inspector Comment

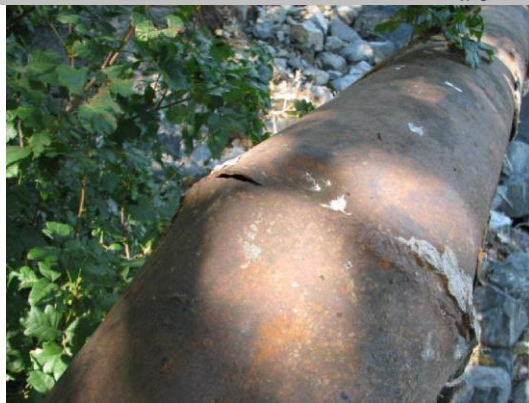
Photo 3 of 3 : UCIP_SP_2018_4980_6628.jpg

small holes in pipe along welded seam.

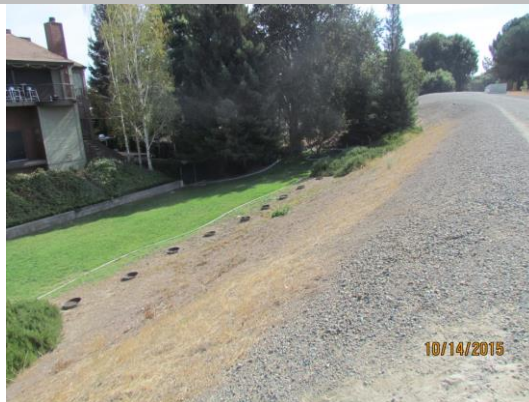
Photo 1 of 1 : SP_2018_MA0009_201_155_20180306_00107.jpg

LM Start	5.96	Rating **	M	Issue No.	155
LM End	5.99	Issue Type +	En	Location *	LS
Category	Earthen Levee			GPS Latitude/Longitude	
				Start	End
Item	Vegetation			38.483639 °	38.483310 °
				-121.547532 °	-121.547297 °
DWR ID	DWR_MA0009_01_s_2012_155				
Comment Code					
V6 : Landscaping					
Inspector Comment

View of the garden on the landward side of the levee looking downhill. Fall 2015.

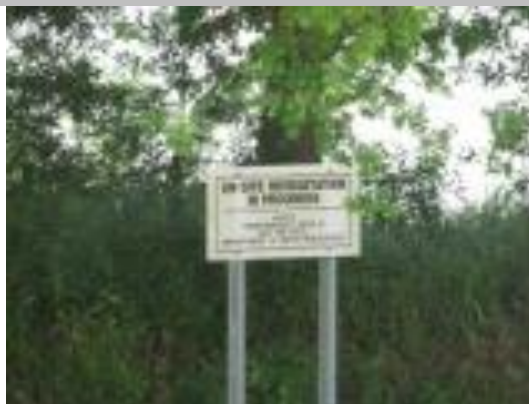
Photo 1 of 2 : SP_2018_MA0009_201_134_20180306_00084.jpg

LM Start	6.13	Rating **	A/W	Issue No.	134
LM End	6.25	Issue Type +	En	Location *	WS
Category	Earthen Levee			GPS Latitude/Longitude	
				Start	End
Item	Vegetation			38.481560 °	38.480129 °
				-121.545850 °	-121.544858 °
DWR ID	DWR_MA0009_01_s_2012_134				
Comment Code					
V8 : Environmental Requirements.					
Inspector Comment

A revegetation site. Photo taken spring 2012.

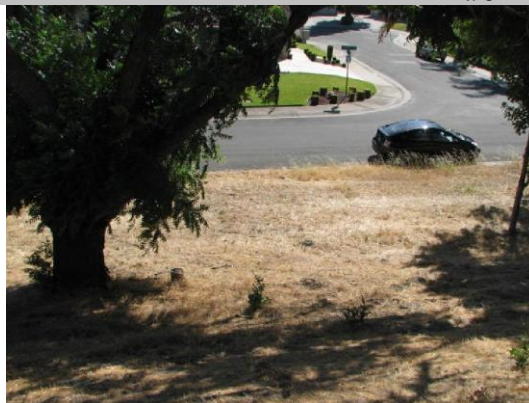
Photo 1 of 1 : UCIP_SP_2018_41067_6688.jpg

LM Start	6.16	Rating **	M	Issue No.	1794
LM End	6.16	Issue Type +	En	Location *	
Category	Supplemental			GPS Latitude/Longitude	
				Start	End
Item	DWR UCIP Field Study			38.481270 °	38.481270 °
				-121.545630 °	-121.545630 °
DWR ID					
Comment Code					
Inspector Comment					
FS_ID:41067 DS_ID:17379 EP_NO: N/A Repair Type: Non-Urgent Crossing Status: Indicator Found UCIP Comments: remains of a cut off telephone pole 50-feet downstream from this location may be good indicator of abandoned pipe location. FIELD_STRUCT_DESC: 6-inch pipe through the levee approximately 17-feet below the crown. Constructed with 1-cm cut-off wall and pump and check valve on river side. Pipe has been plugged and abandoned in place 10/31/89. Originally included in O+M manual (1955). FS Date: 6/21/2012 3:50:00 PM

Sawed off power pole at LS toe 50-feet Downstream from pipe location may be good indicator of Abandoned pipe location.

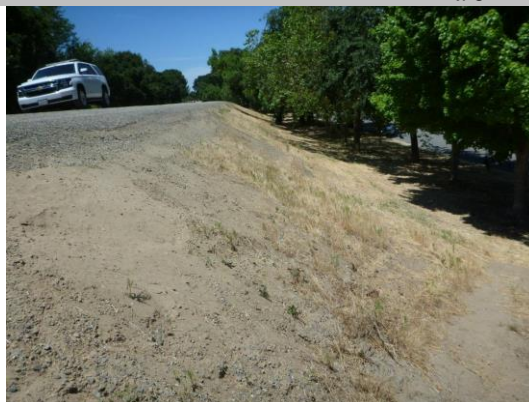
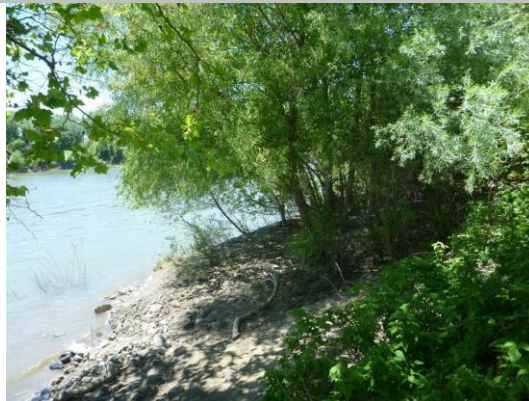
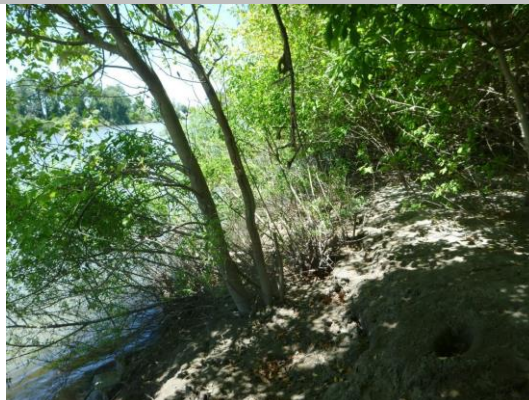
LM Start	6.24	Rating **	A/W	Issue No.	249
LM End	6.24	Issue Type +	Ma	Location *	
Category	Supplemental			GPS Latitude/Longitude	
				Start	End
Item	2017 Storm Damage			38.480251 °	38.480199 °
				-121.544900 °	-121.544865 °
DWR ID	DWR_MA0009_01_f_2017_249				
Comment Code					
Inspector Comment					
Levee Evaluation Comments					
Description:					
Site ID No:234					
Site Designation:LMA-67					
Repair Type: Erosion					
Rating:Area of Concern					
Field Date:6/2/2017					
Notes: Footpath on landside slope.

LM Start	6.24	Rating **	A/W	Issue No.	249 (cont)	
LM End	6.24	Issue Type +	Ma	Location *		
Category	Supplemental			GPS Latitude/Longitude		
				Start		End
Item	2017 Storm Damage			38.480251 °	38.480199 °	
				-121.544900 °	-121.544865 °	
DWR ID	DWR_MA0009_01_f_2017_249					
Comment Code						
Inspector Comment						
Levee Evaluation Comments						
Description:						
Site ID No:234						
Site Designation:LMA-67						
Repair Type: Erosion						
Rating:Area of Concern						
Field Date:6/2/2017						
Notes: Footpath on landside slope.

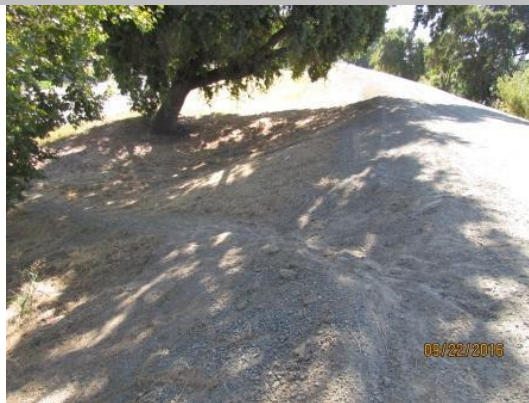
Photo 1 of 2 : SP_2018_MA0009_201_337_20180306_00274.jpg

LM Start	6.24	Rating **	A/W	Issue No.	337
LM End	6.24	Issue Type +	Ma	Location *	LS
Category	Earthen Levee			GPS Latitude/Longitude	
				Start	End
Item	Slope Stability			38.480209 °	38.480209 °
				-121.544893 °	-121.544893 °
DWR ID	DWR_MA0009_01_f_2015_337				
Comment Code					
S2 : Repair the levee slope damaged by foot traffic and prevent access where possible.					
Inspector Comment					
Footpath on landside slope.

View of footpath that causes slope stability on LS of the levee. Fall 2016.

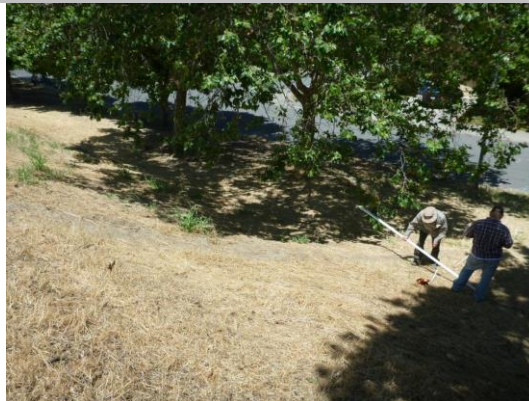
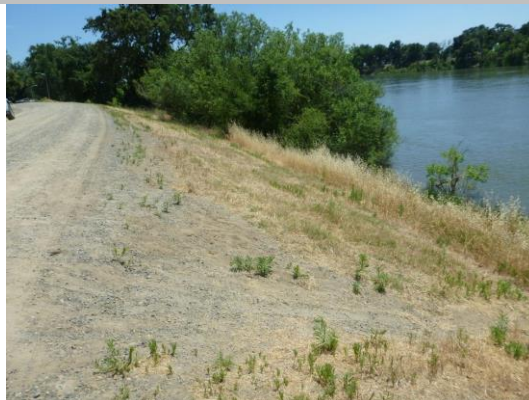
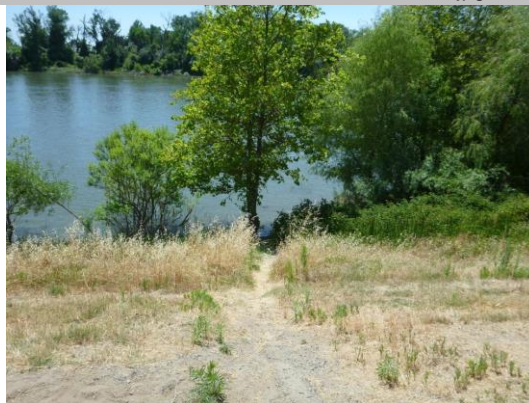
LM Start	6.25	Rating **	A/W	Issue No.	250	
LM End	6.25	Issue Type +	Ma	Location *		
Category	Supplemental			GPS Latitude/Longitude		
				Start		End
Item	2017 Storm Damage			38.480124 °	38.480099 °	
				-121.544812 °	-121.544795 °	
DWR ID	DWR_MA0009_01_f_2017_250					
Comment Code						
Inspector Comment						
Levee Evaluation Comments						
Description:						
Site ID No:235						
Site Designation:LMA-68						
Repair Type: Erosion						
Rating:Area of Concern						
Field Date:6/6/2017						
Notes: Erosion on existing landside footpaths.

LM Start	6.25	Rating **	A/W	Issue No.	250 (cont)	
LM End	6.25	Issue Type +	Ma	Location *		
Category	Supplemental			GPS Latitude/Longitude		
				Start		End
Item	2017 Storm Damage			38.480124 °	38.480099 °	
				-121.544812 °	-121.544795 °	
DWR ID	DWR_MA0009_01_f_2017_250					
Comment Code						
Inspector Comment						
Levee Evaluation Comments						
Description:						
Site ID No:235						
Site Designation:LMA-68						
Repair Type: Erosion						
Rating:Area of Concern						
Field Date:6/6/2017						
Notes: Erosion on existing landside footpaths.

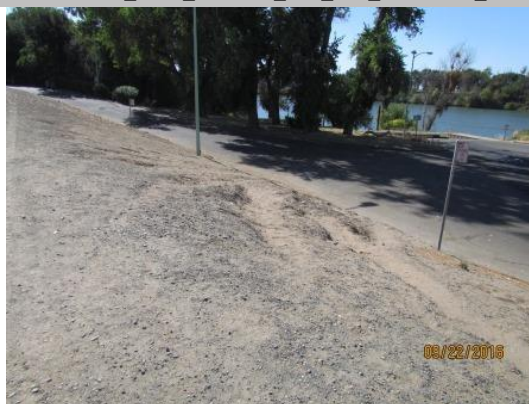
Photo 1 of 2 : SP_2018_MA0009_201_375_20180306_00302.jpg

View of slope stability on WS of the levee. Fall 2016.

LM Start	6.37	Rating **	M	Issue No.	375
LM End	6.37	Issue Type +	Ma	Location *	WS
Category	Earthen Levee			GPS Latitude/Longitude	
				Start	End
Item	Slope Stability			38.478698 °	38.478698 °
				-121.543333 °	-121.543333 °
DWR ID	DWR_MA0009_01_s_2016_375				
Comment Code					
S3 : Repair the levee slope damaged by vehicle traffic and prevent access where possible.					
Inspector Comment

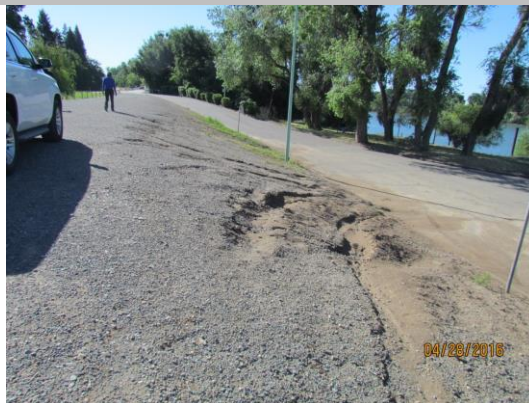
Photo 2 of 2 : SP_2018_MA0009_201_375_20180306_00303.jpg

View of the slope stability on the waterward side of the levee looking downstream. Spring 2016.

LM Start	6.37	Rating **	M	Issue No.	375 (cont)	
LM End	6.37	Issue Type +	Ma	Location *	WS	
Category	Earthen Levee			GPS Latitude/Longitude		
				Start		End
Item	Slope Stability			38.478698 °		38.478698 °
				-121.543333 °		-121.543333 °
DWR ID	DWR_MA0009_01_s_2016_375					
Comment Code						
S3 : Repair the levee slope damaged by vehicle traffic and prevent access where possible.						
Inspector Comment

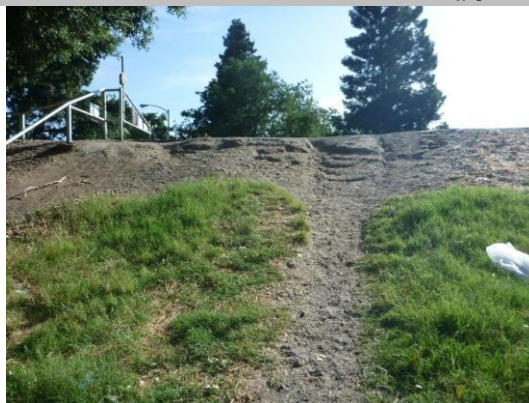
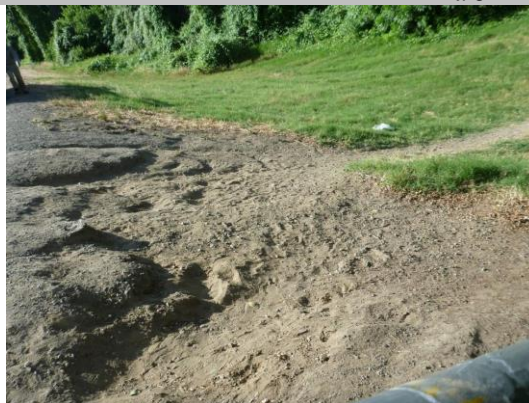
LM Start	6.43	Rating **	M	Issue No.	266
LM End	6.44	Issue Type +	Ma	Location *	
Category	Supplemental			GPS Latitude/Longitude	
				Start	End
Item	2017 Storm Damage			38.478089 °	38.478050 °
				-121.542623 °	-121.542581 °
DWR ID	DWR_MA0009_01_f_2017_266				
Comment Code					
Inspector Comment					
Levee Evaluation Comments					
Description:					
Site ID No:236					
Site Designation:LMA-69					
Repair Type: Erosion					
Rating:Area of Concern					
Field Date:6/7/2017					
Notes: upper waterside levee slope erosion appeared caused from runoff from paved crown and foot traffic

LM Start	6.43	Rating **	M	Issue No.	266 (cont)
LM End	6.44	Issue Type +	Ma	Location *	
Category	Supplemental			GPS Latitude/Longitude	
				Start	End
Item	2017 Storm Damage			38.478089 °	38.478050 °
				-121.542623 °	-121.542581 °
DWR ID	DWR_MA0009_01_f _ 2017_266				
Comment Code					
Inspector Comment					
Levee Evaluation Comments					
Description:					
Site ID No:236					
Site Designation:LMA-69					
Repair Type: Erosion					
Rating:Area of Concern					
Field Date:6/7/2017					
Notes: upper waterside levee slope erosion appeared caused from runoff from paved crown and foot traffic

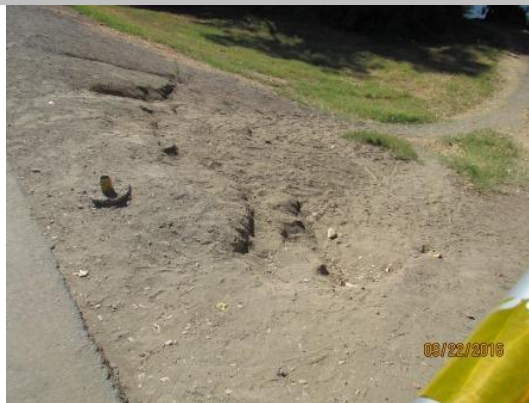
Photo 1 of 3 : SP_2018_MA0009_201_339_20180306_00276.jpg

LM Start	6.43	Rating **	A/W	Issue No.	339
LM End	6.43	Issue Type +	Ma	Location *	WS
Category	Earthen Levee			GPS Latitude/Longitude	
				Start	End
Item	Slope Stability			38.478082 °	38.478082 °
				-121.542589 °	-121.542589 °
DWR ID	DWR_MA0009_01_f_2015_339				
Comment Code					
S2 : Repair the levee slope damaged by foot traffic and prevent access where possible.					
Inspector Comment

An updated view of slope stability site. WS slope of the levee. Fall 2016.

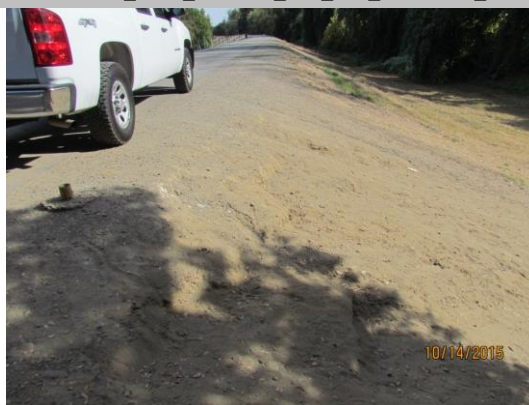
Photo 2 of 3 : SP_2018_MA0009_201_339_20180306_00277.jpg

Perspective view of the slope stability on the waterward side of the levee looking downstream. Fall 2015.

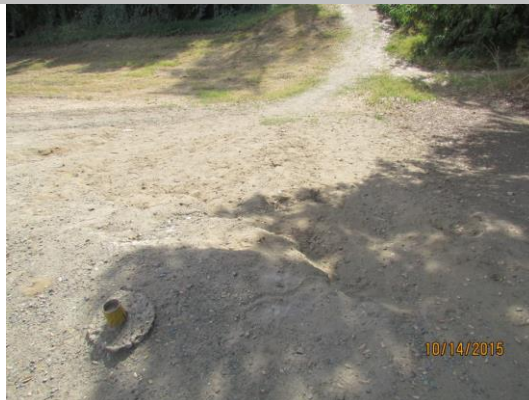
Photo 3 of 3 : SP_2018_MA0009_201_339_20180306_00278.jpg

Slope stability is caused by foot traffic. Fall 2015.

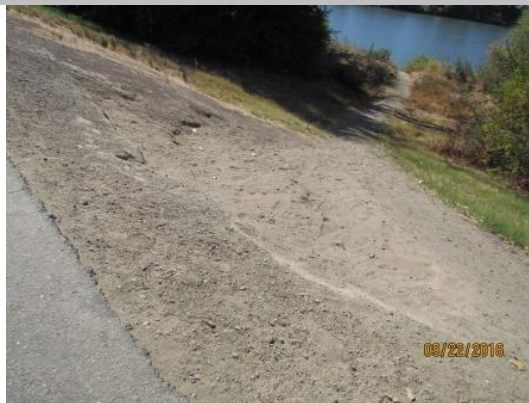
Photo 1 of 3 : SP_2018_MA0009_201_301_20180306_00240.jpg

LM Start	6.53	Rating **	M	Issue No.	301
LM End	6.53	Issue Type +	Ma	Location *	WS
Category	Earthen Levee			GPS Latitude/Longitude	
				Start	End
Item	Slope Stability			38.477116 °	38.477116 °
				-121.541253 °	-121.541253 °
DWR ID	DWR_MA0009_01_s_2015_301				
Comment Code					
S2 : Repair the levee slope damaged by foot traffic and prevent access where possible.					
Inspector Comment					
Footpath on waterside slope.

An updated view of slope stability site. Waterward side of the levee. Fall 2016.

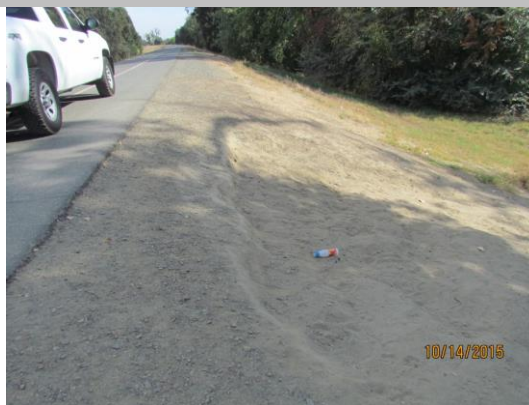
Photo 2 of 3 : SP_2018_MA0009_201_301_20180306_00241.jpg

Perspective view of the slope stability on the waterward side of the levee looking downstream. Fall 2015.

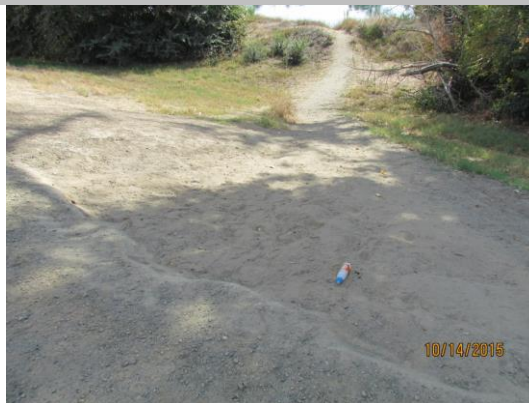
Photo 3 of 3 : SP_2018_MA0009_201_301_20180306_00242.jpg

Looking at the trail caused by foot traffic. Fall 2015.

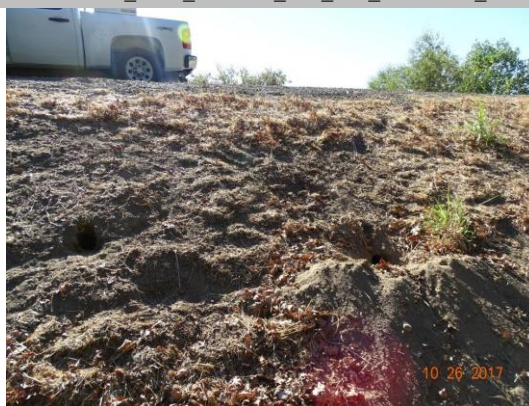
Photo 2 of 2 : SP_2018_MA0009_201_418_20180306_00315.jpg

LM Start	6.77	Rating **	M	Issue No.	418 (cont)	
LM End	6.77	Issue Type +	Ma	Location *	LS	
Category	Earthen Levee			GPS Latitude/Longitude		
				Start		End
Item	Animal Control			38.475359 °		38.475359 °
				-121.537557 °		-121.537557 °
DWR ID	DWR_MA0009_01_f_2017_418					
Comment Code						
A1 : Exterminate rodents and backfill and compact or grout burrows.						
Inspector Comment						
Multiple holes on landside slope.

Additional view of holes on landside slope. Fall 2017.

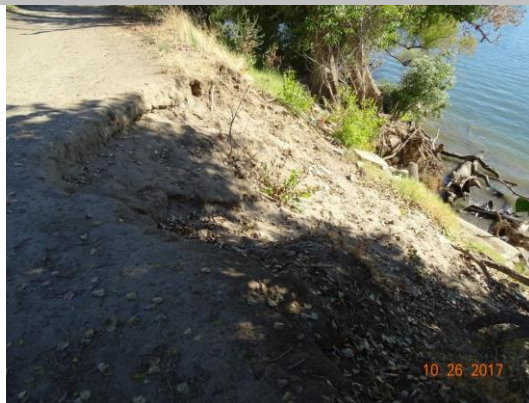
Photo 1 of 2 : SP_2018_MA0009_201_267_20180306_00212.jpg

Notes: This site was visited but no data was recorded at the time. The Sac Yard is planning on repairing this site by the end of November this year. Erosion cuts into WS toe road, but is not within the prism.

View of erosion on berm road. Fall 2017.

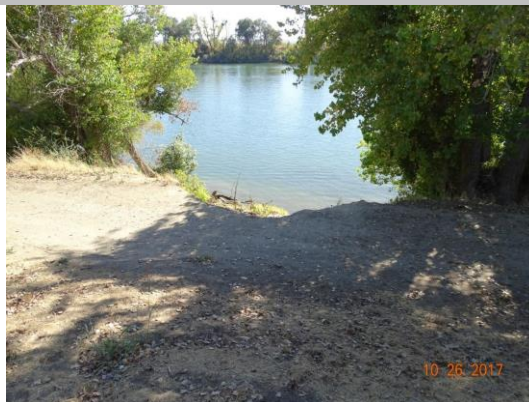
Photo 2 of 2 : SP_2018_MA0009_201_267_20180306_00213.jpg

Additional view of erosion. Fall 2017.

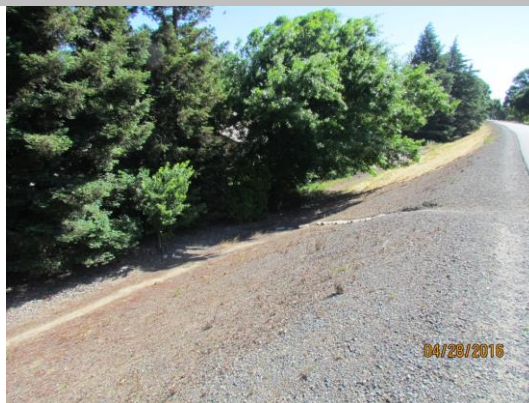
Photo 1 of 1 : SP_2018_MA0009_201_158_20180306_00108.jpg

LM Start	7.25	Rating **	M	Issue No.	158
LM End	7.25	Issue Type +	En	Location *	LS
Category	Earthen Levee			GPS Latitude/Longitude	
				Start	End
Item	Vegetation			38.474861 °	38.474861 °
				-121.528804 °	-121.528804 °
DWR ID	DWR_MA0009_01_s _ 2012_158				
Comment Code					
V6 : Landscaping					
Inspector Comment

View of the landscaping on the landward side of the levee looking downstream. Landscape is borderline at easement of toe. Spring 2016.

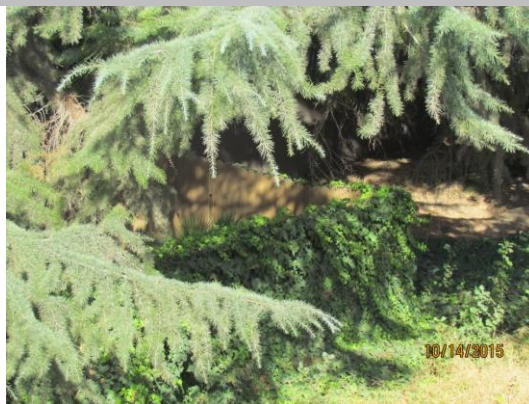
Photo 1 of 2 : SP_2018_MA0009_201_159_20180306_00109.jpg

LM Start	7.30	Rating **	U	Issue No.	159
LM End	7.32	Issue Type +	En	Location *	LS
Category	Earthen Levee			GPS Latitude/Longitude	
				Start	End
Item	Encroachments			38.474916 °	38.474942 °
				-121.527760 °	-121.527482 °
DWR ID	DWR_MA0009_01_s _ 2012_159				
Comment Code					
FE : Fence					
Inspector Comment

The solid fence is located in the trees on the landward side of the levee. Fall 2015.

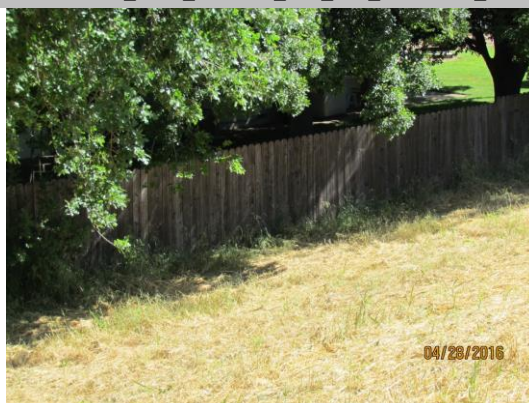
Photo 1 of 2 : SP_2018_MA0009_201_162_20180306_00113.jpg

LM Start	7.44	Rating **	U	Issue No.	162
LM End	7.44	Issue Type +	En	Location *	LS
Category	Earthen Levee			GPS Latitude/Longitude	
				Start	End
Item	Encroachments			38.475156 °	38.475156 °
				-121.525212 °	-121.525212 °
DWR ID	DWR_MA0009_01_s_2012_162				
Comment Code					
FE : Fence					
Inspector Comment

A wooden fence is near the toe of the levee. Spring 2016.

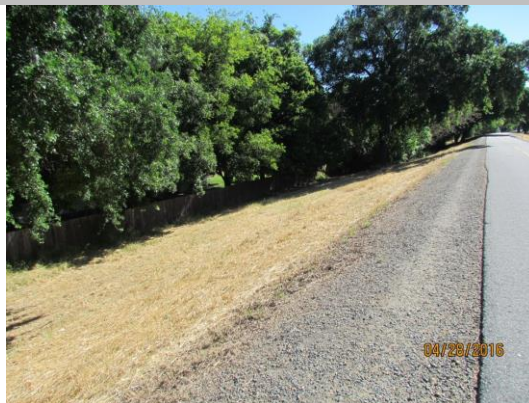
Photo 2 of 2 : SP_2018_MA0009_201_162_20180306_00114.jpg

Perspective view of the wooden fence on the landward side of the levee looking downstream. Spring 2016.

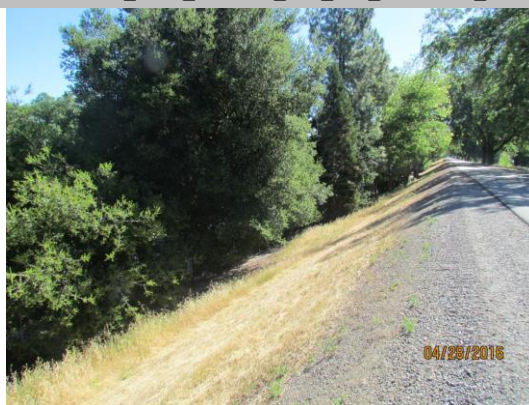
Photo 1 of 2 : SP_2018_MA0009_201_164_20180306_00116.jpg

LM Start	7.51	Rating **	M	Issue No.	164
LM End	7.61	Issue Type +	En	Location *	LS
Category	Earthen Levee			GPS Latitude/Longitude	
				Start	End
Item	Vegetation			38.475270 °	38.475360 °
				-121.524036 °	-121.522178 °
DWR ID	DWR_MA0009_01_s_2012_164				
Comment Code					
V6 : Landscaping					
Inspector Comment

View of the trees along the toe of the levee on the landward side looking downstream. Spring 2016.

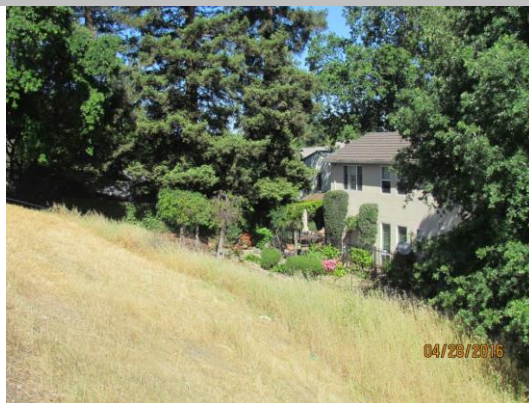
Photo 2 of 2 : SP_2018_MA0009_201_164_20180306_00117.jpg

View of the landscaping and fence at the toe of the levee on the landward side looking upstream. Spring 2016.

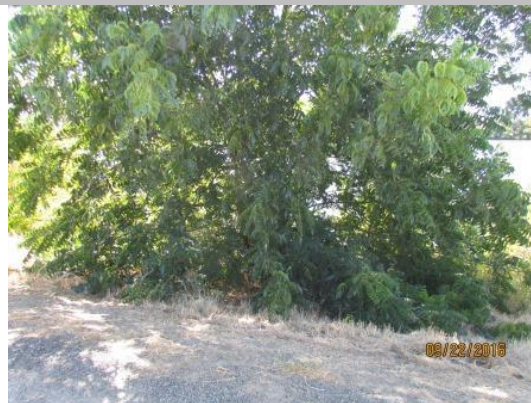
Photo 1 of 1 : SP_2018_MA0009_201_252_20180306_00203.jpg

LM Start	8.05	Rating **	M	Issue No.	252
LM End	8.05	Issue Type +	Ma	Location *	WS
Category	Earthen Levee			GPS Latitude/Longitude	
				Start	End
Item	Trim / Thin Trees			38.475340 °	38.475340 °
				-121.514076 °	-121.514076 °
DWR ID	DWR_MA0009_01_f_2016_252				
Comment Code					
T1 : Trim trees to at least five feet above ground level.					
Inspector Comment

Tree trimming needed at WS slope of the levee. Fall 2016.

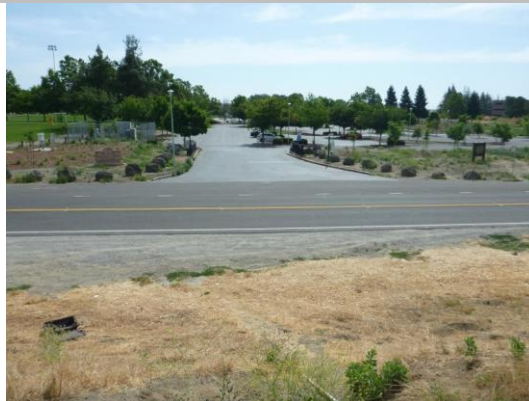
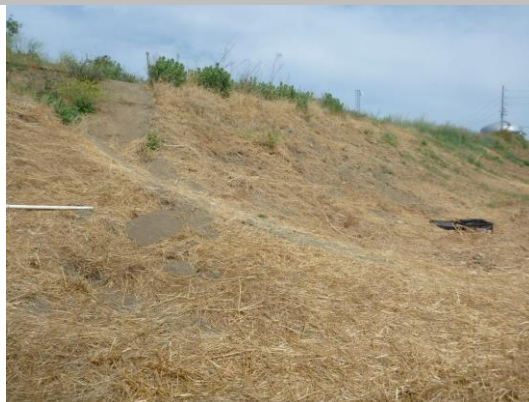
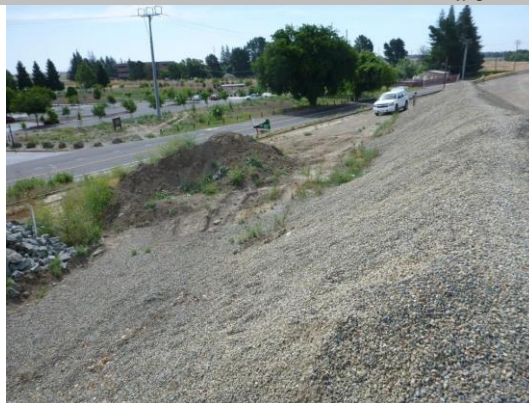
LM Start	8.68	Rating **	A/W	Issue No.	269
LM End	8.68	Issue Type +	Ma	Location *	
Category	Supplemental			GPS Latitude/Longitude	
				Start	End
Item	2017 Storm Damage			38.471157 °	38.471131 °
				-121.503889 °	-121.503884 °
DWR ID	DWR_MA0009_01_f_2017_269				
Comment Code					
Inspector Comment					
Levee Evaluation Comments					
Description:					
Site ID No:237					
Site Designation:LMA-70					
Repair Type: Erosion					
Rating:Area of Concern					
Field Date:6/7/2017					
Notes: landside levee slope damage from foot traffic; no cross section taken; photo only, at this location levee has over 138' crown width; crown width relates to the landside railroad trails.

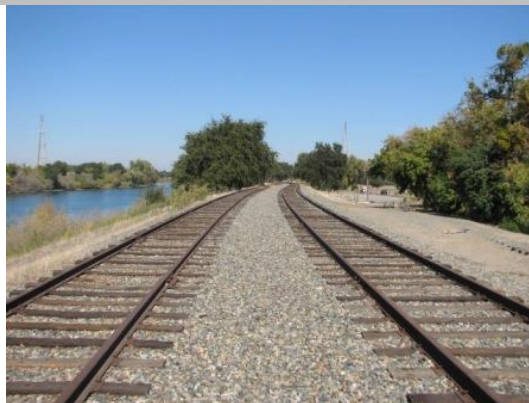
Photo 1 of 2 : SP_2018_MA0009_201_166_20180306_00119.jpg

LM Start	8.76	Rating **	M	Issue No.	166
LM End	10.52	Issue Type +	En	Location *	CR
Category	Earthen Levee			GPS Latitude/Longitude	
				Start	End
Item	Encroachments			38.469929 °	38.444723 °
				-121.503668 °	-121.500283 °
DWR ID	DWR_MA0009_01_s_2012_166				
Comment Code					
EQ : Equipment					
Inspector Comment					
Encroachment is railroad tracks (equipment), access is very limited, no patrol access, vegetation maint. is difficult. Tracks end at Cliff's Marina where Highway 160 crosses tracks, LM 9.36-9.80 is the town of Freeport with many encroachments.

Railroad tracks are on the crown preventing ability to patrol during flood season. Fall 2013

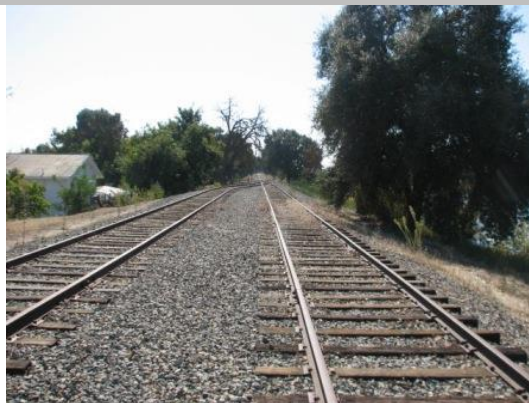
Photo 2 of 2 : SP_2018_MA0009_201_166_20180306_00120.jpg

Looking downstream towards Freeport. Fall 2013

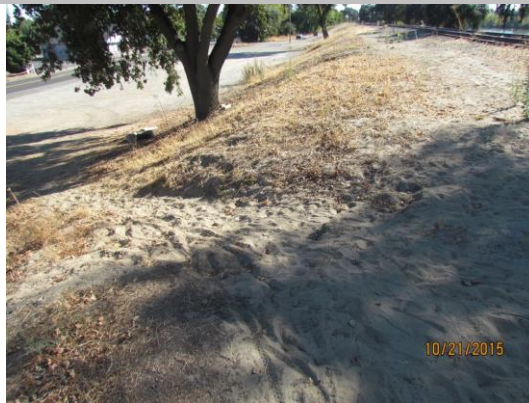
Photo 1 of 1 : SP_2018_MA0009_201_346_20180306_00281.jpg

LM Start	9.08	Rating **	M	Issue No.	346
LM End	9.08	Issue Type +	Ma	Location *	LS
Category	Earthen Levee			GPS Latitude/Longitude	
				Start	End
Item	Slope Stability			38.465278 °	38.465278 °
				-121.503210 °	-121.503210 °
DWR ID	DWR_MA0009_01_f_2015_346				
Comment Code					
S2 : Repair the levee slope damaged by foot traffic and prevent access where possible.					
Inspector Comment

View of the slope stability caused by foot traffic on the landward side of the levee looking downstream. Fall 2015.

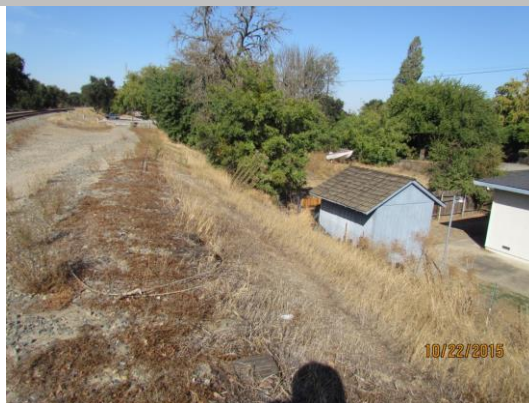
Photo 1 of 1 : SP_2018_MA0009_201_168_20180306_00121.jpg

LM Start	9.23	Rating **	M	Issue No.	168
LM End	9.23	Issue Type +	En	Location *	LS
Category	Earthen Levee			GPS Latitude/Longitude	
				Start	End
Item	Encroachments			38.463138 °	38.463138 °
				-121.502788 °	-121.502788 °
DWR ID	DWR_MA0009_01_s_2012_168				
Comment Code					
BU : Building					
Inspector Comment

View of the building at the toe of the landward side of the levee looking upstream. Fall 2015.
